**ARMY PRELIMINARY EVALUATION YAH-1R IMPROVED COBRA  
AGILITY AND MANEUVERABILITY HELICOPTER**

USAAEFA PROJECT NO. 74-33

## **FINAL REPORT**

**UNITED STATES ARMY AVIATION ENGINEERING FLIGHT ACTIVITY  
EDWARDS AIR FORCE BASE, CALIFORNIA 93523**

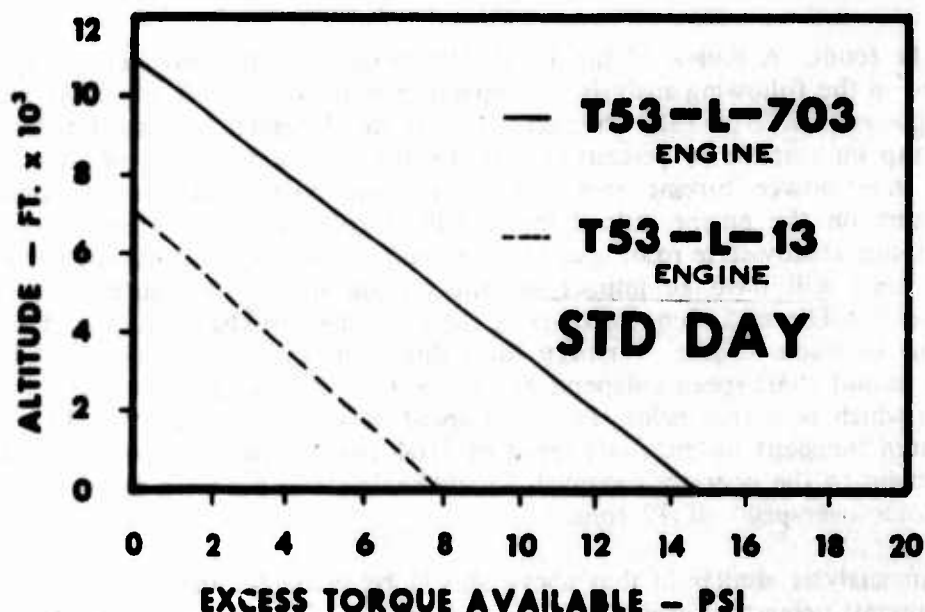
Figure A. Steady-State Overtorque Capability.

48. The increased power available in the YAH-1R helicopter and the increased drive train power transmission capability provide a significant increase in the load-carrying and maneuvering capability over previous AH-1 aircraft. Utilizing the aircraft to the extent of its capability will require frequent periods of operation at or near the transmission power limit. The T53-L-703 engine provides significantly more power at a given altitude or the ability to maintain limit power level to a higher altitude and/or temperature. Figure A shows a comparison of the amount of transmission overtorque it is possible to achieve in steady-state nonmaneuvering flight with the T53-L-13 and T53-L-703 engines. Since the aircraft will be operated near transmission limit to realize its increased capability, and since inadvertent overpower conditions can be more serious with the higher power available, it is essential that the pilot be acutely aware of exactly what power level he is demanding.

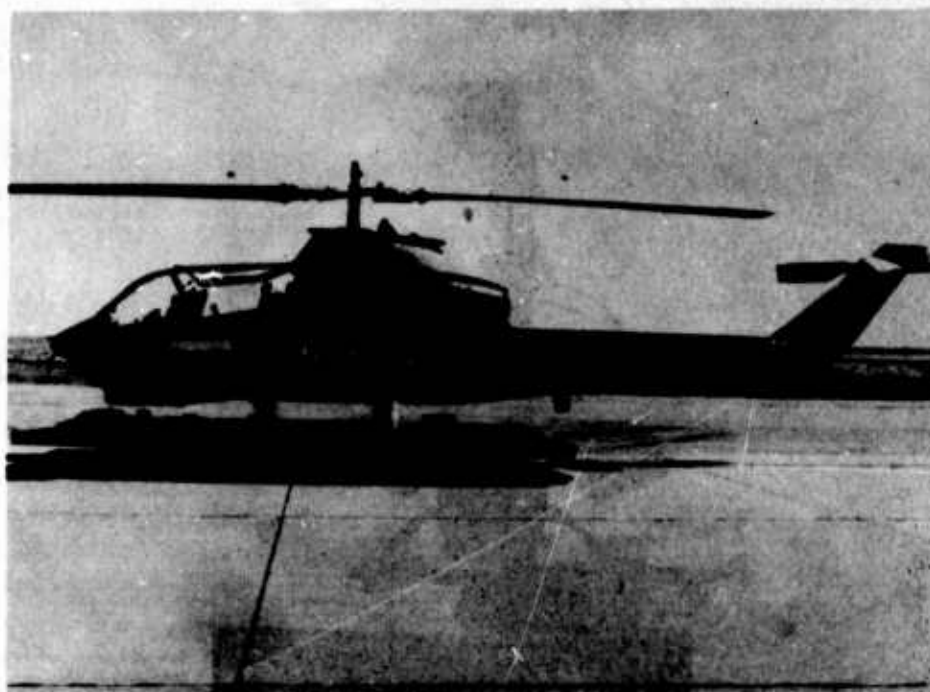
**Photo 1. Left Side View, YAH-1R Helicopter.**

Instrumentation was installed in the test aircraft by BHC prior to the start of the test program and is shown in photos 1 through 6. Two oscillograph recorders were located in the ammunition bay for all testing. All instrumentation was calibrated and maintained by BHC. The following parameters were recorded:

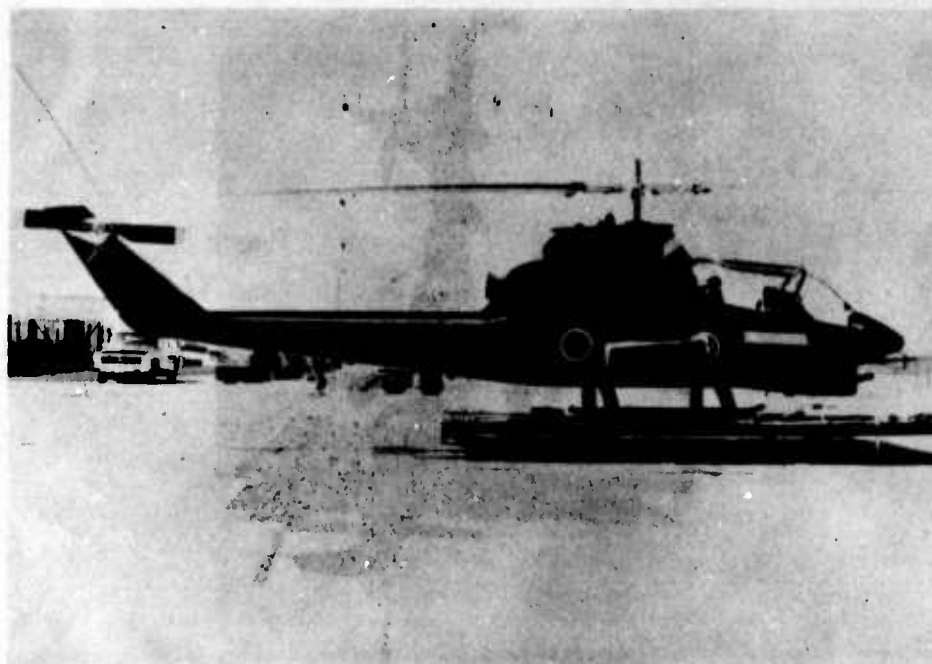
**Photo 2. Right Side View, YAH-1R Helicopter.**

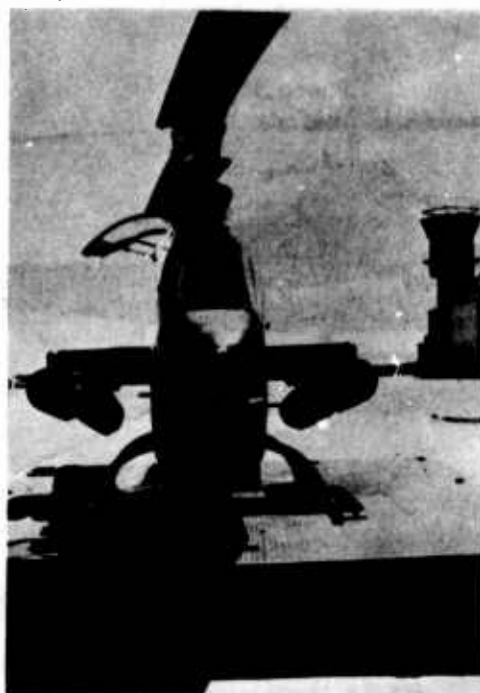
**Photo 3. Front View, YAH-1R Helicopter.**

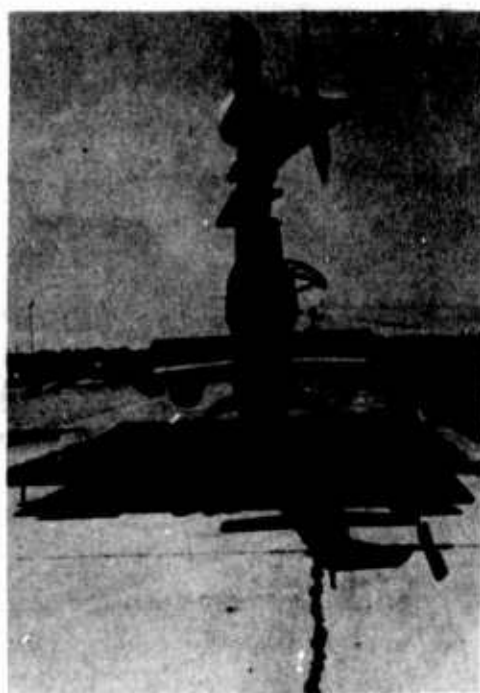
**Photo 4. Rear View, YAH-1R Helicopter.**

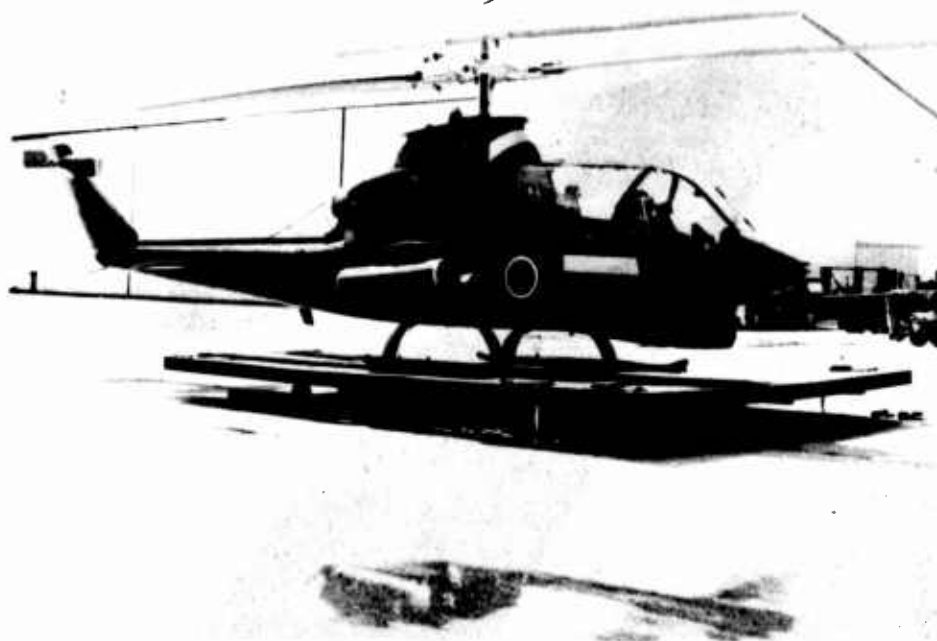
**Photo 5. Right Front View, YAH-1R Helicopter.**

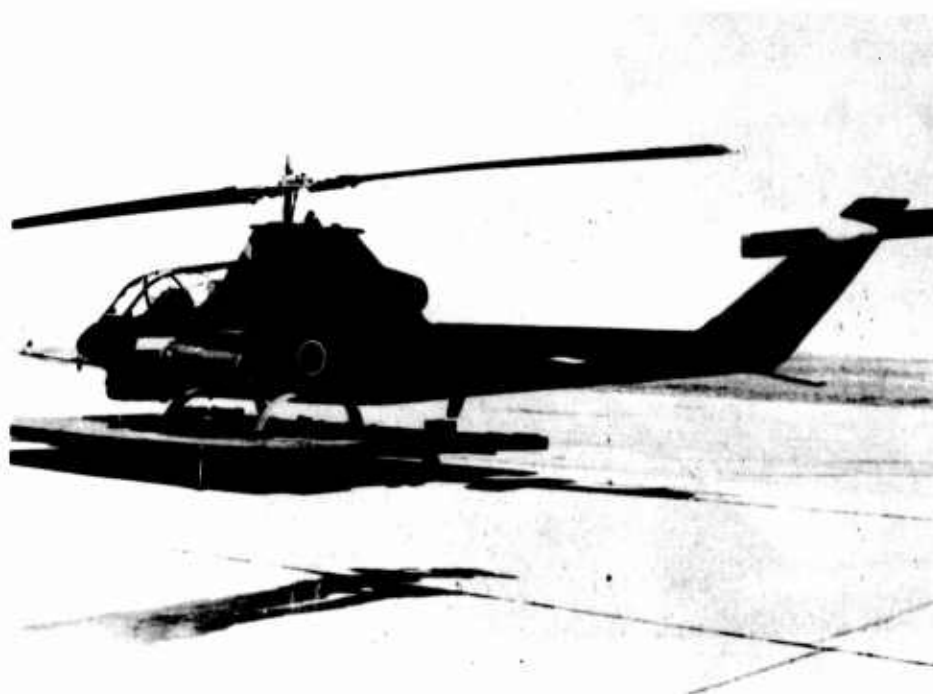
**Photo 6. Left Rear View, YAH-1R Helicopter.**

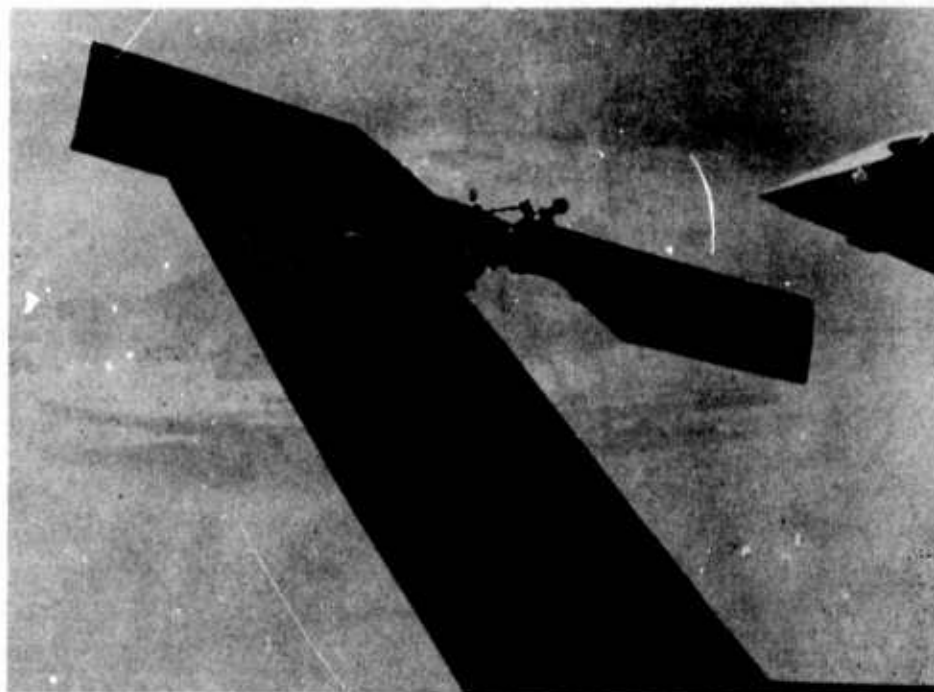
**Photo 7. Model 212 Tail Rotor Installation on the YAH-1R Helicopter.**

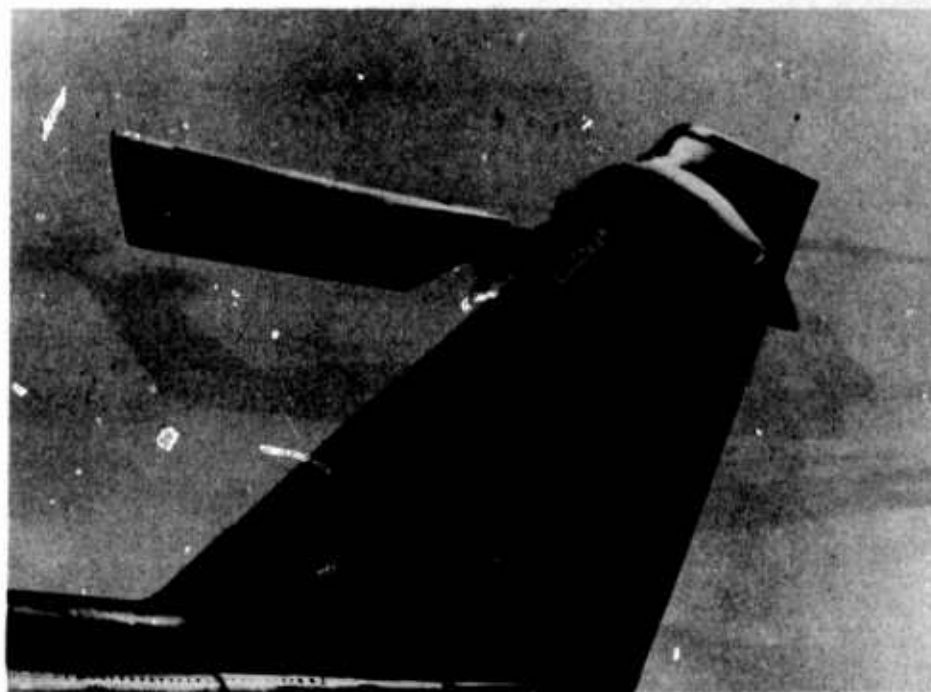
**Photo 8. Detail of 90-Degree Gearbox Fairing, YAH-1R Helicopter.**

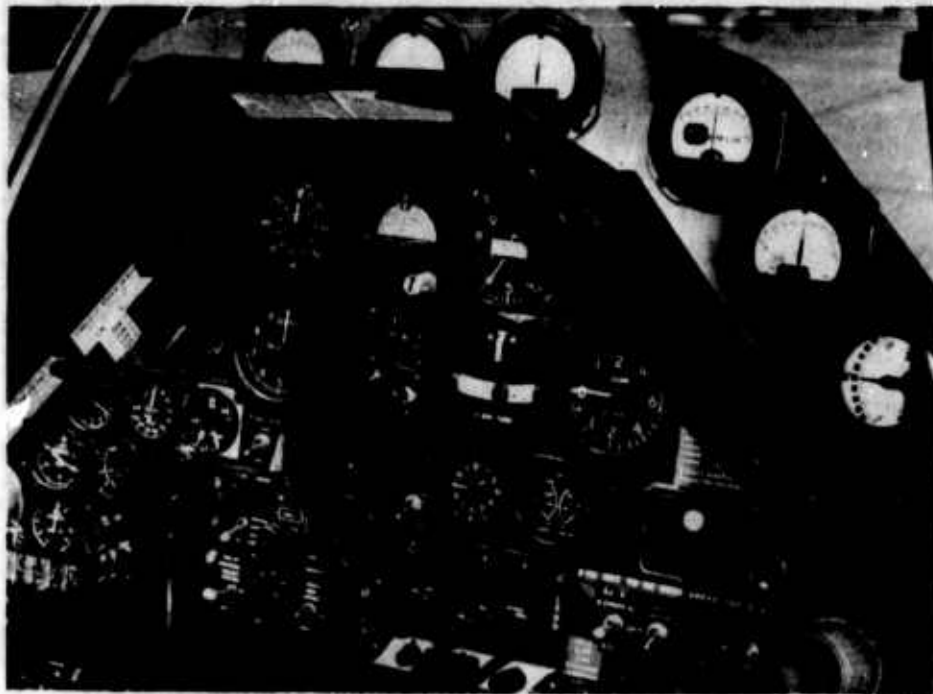
**Photo 1. Pilot Instrument Panel, YAH-1R Test Aircraft.**

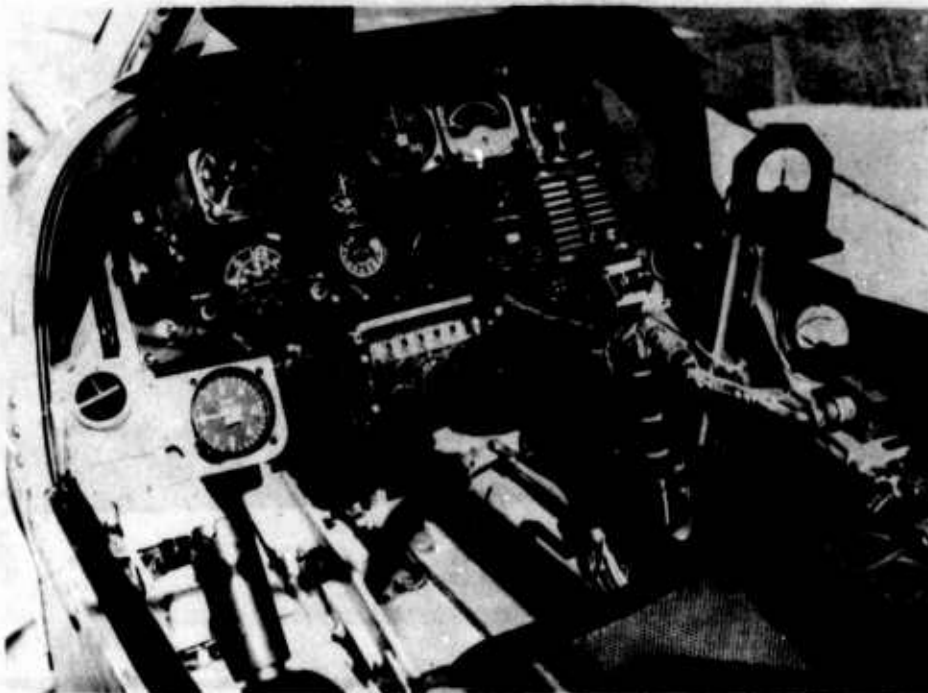
**Photo 2. Engineer Panel, YAH-1R Test Aircraft.**

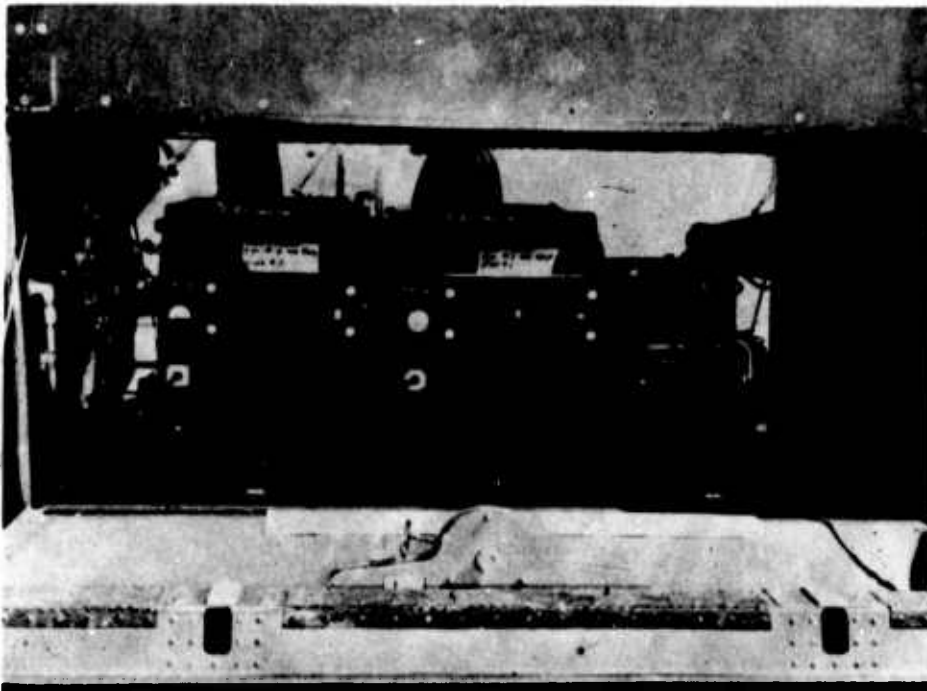
**Photo 4. Oscillograph Installation in Ammunition Bay,  
YAH-1R Helicopter.**

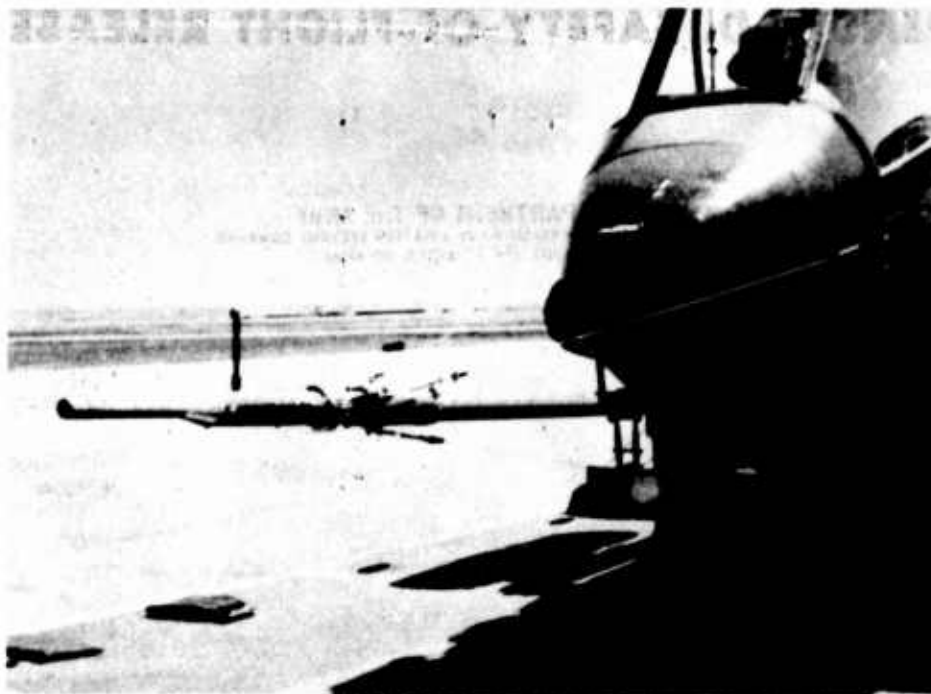
**Photo 5. Nose-Mounted Test Instrumentation Boom,  
YAH-1R Test Aircraft.**

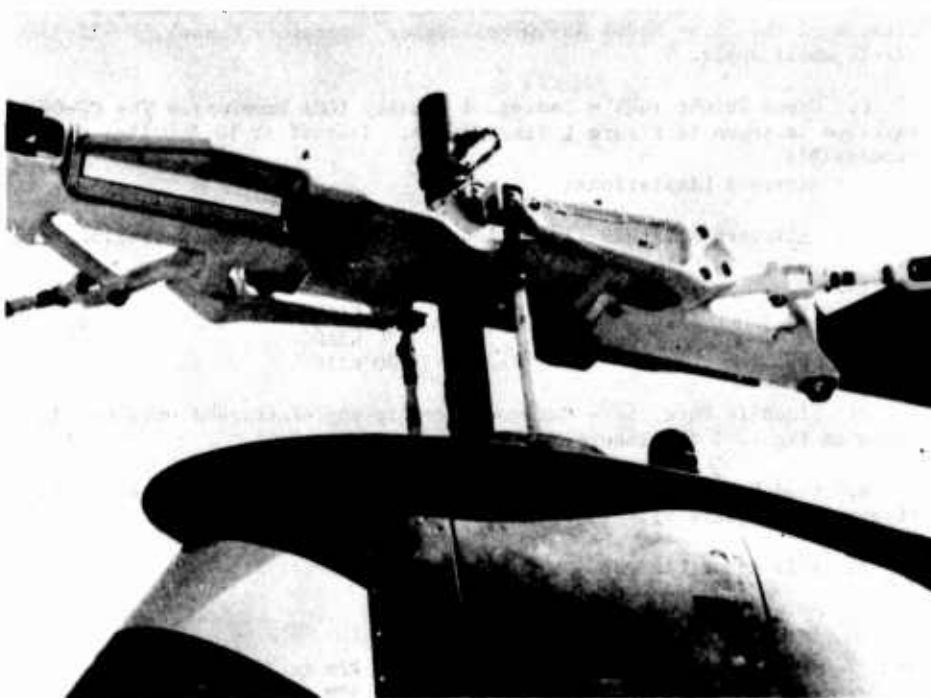
**Photo 6. Main Rotor Rotating Instrumentation, YAH-1R Test Aircraft.**

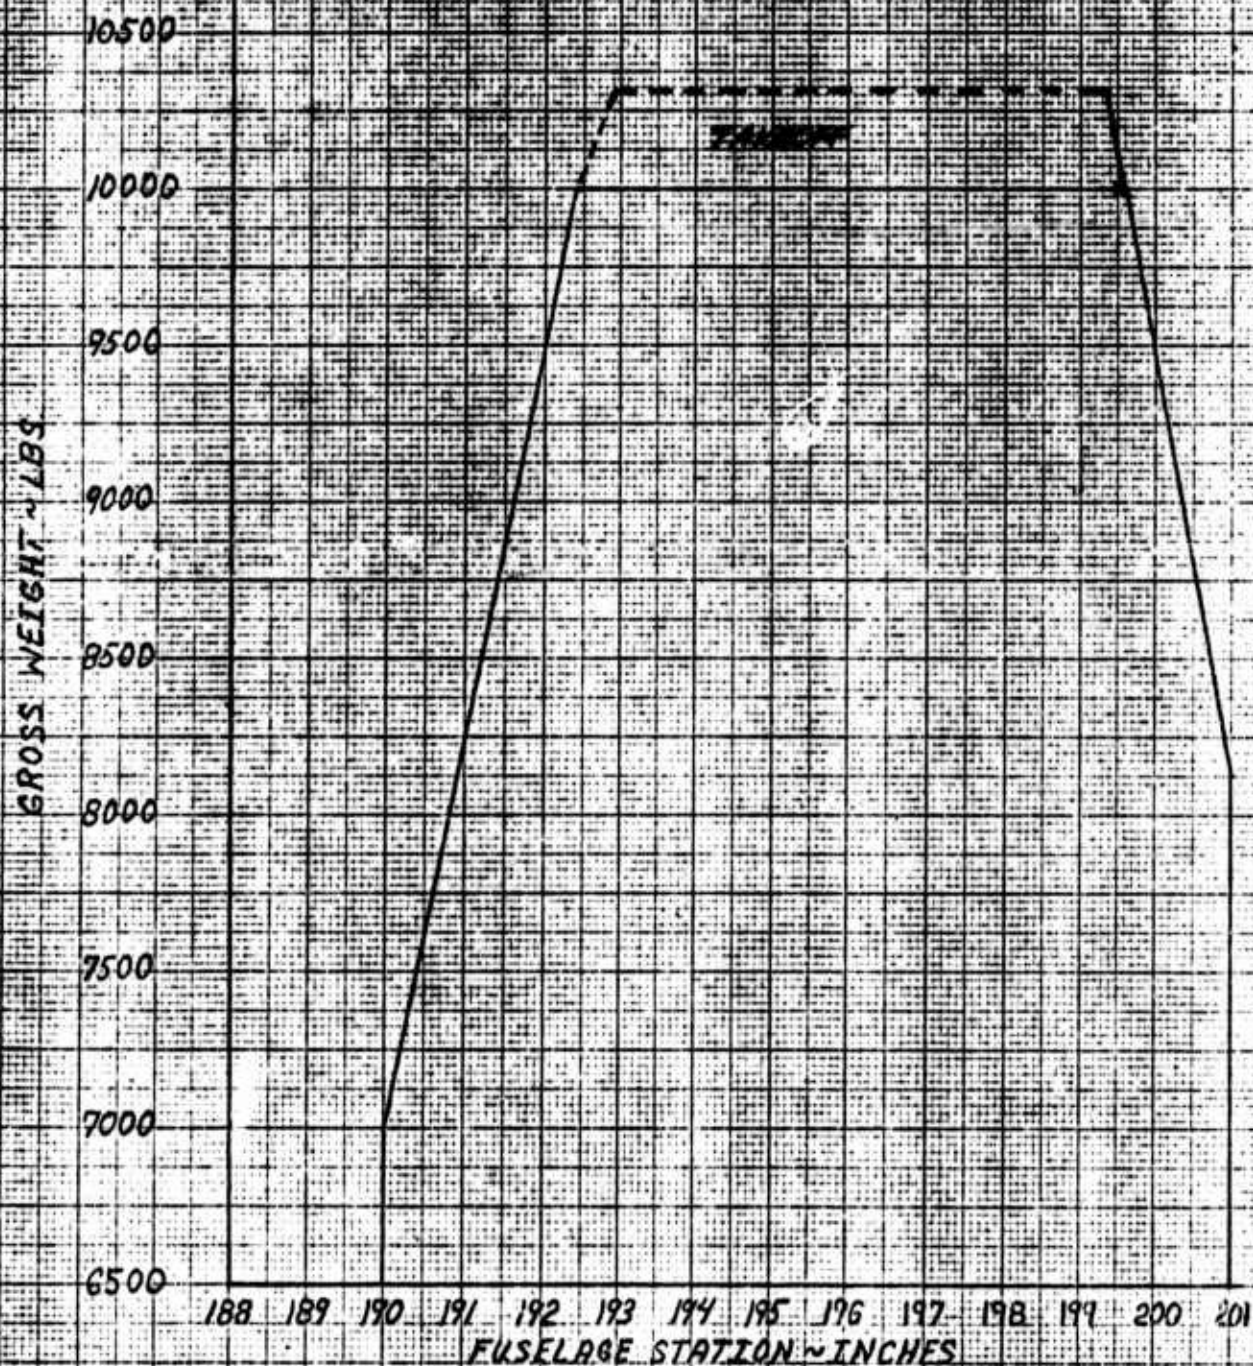
FIGURE 1

# GROSS WEIGHT - CENTER OF GRAVITY ENVELOPE

b. Gross Weight (GW) - Center of Gravity (CG) Envelope - The CG-GW envelope is shown in Figure 1 (inclosure). Takeoff at 10,300 lbs. is permissible.

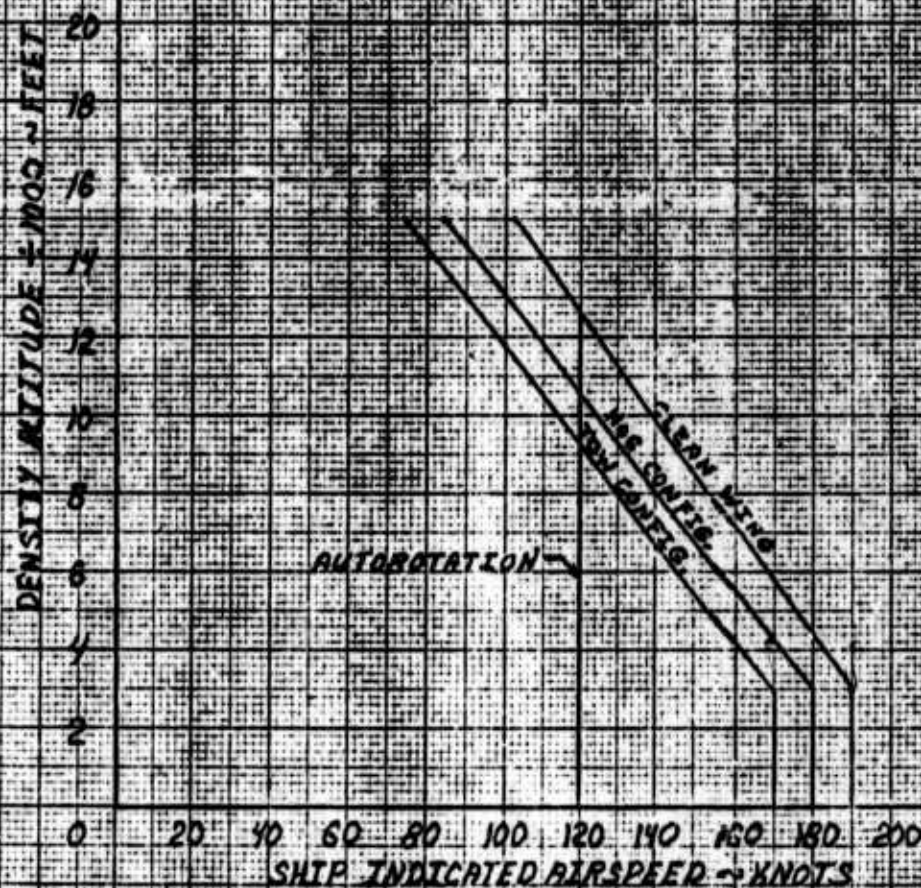
FIGURE 2

# AIRSPPEED - ALTITUDE ENVELOPE

(1) Airspeed/Altitude limitations are shown in Figure 2 (inclosure 2).

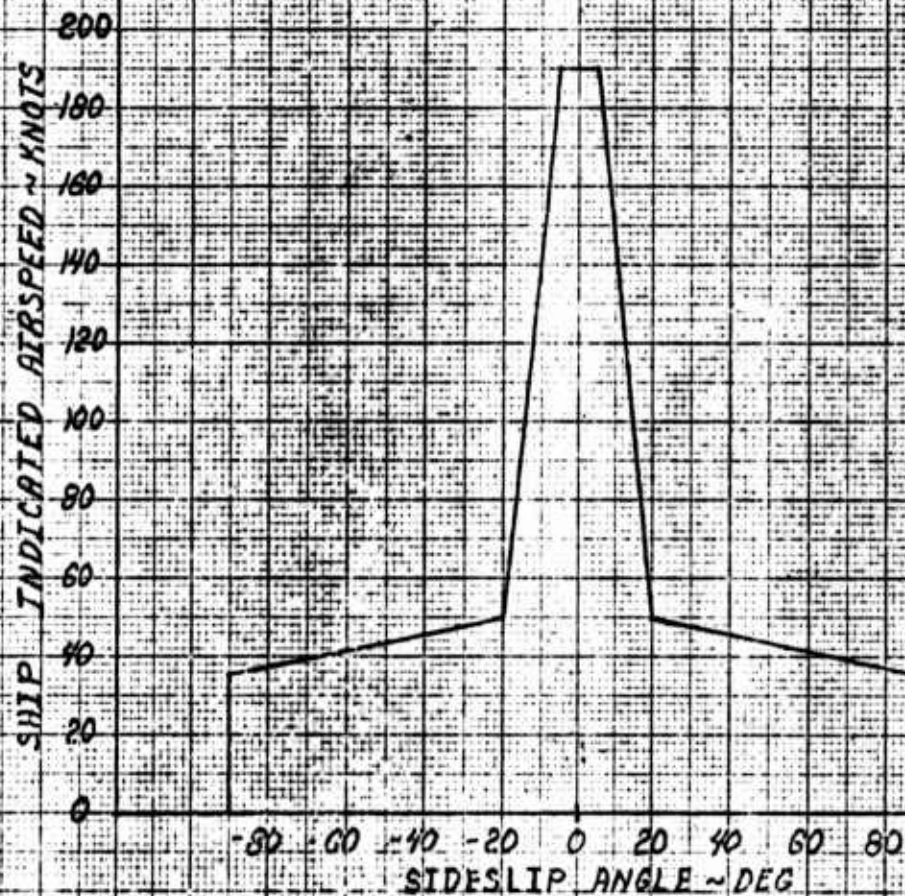
FIGURE 3

AIRSPPEED - SIDESLIP  
ENVELOPE

d. Sideslip Envelope - Maximum sideslip angle/airspeed envelope is shown in Figure 3 (inclosure 3).

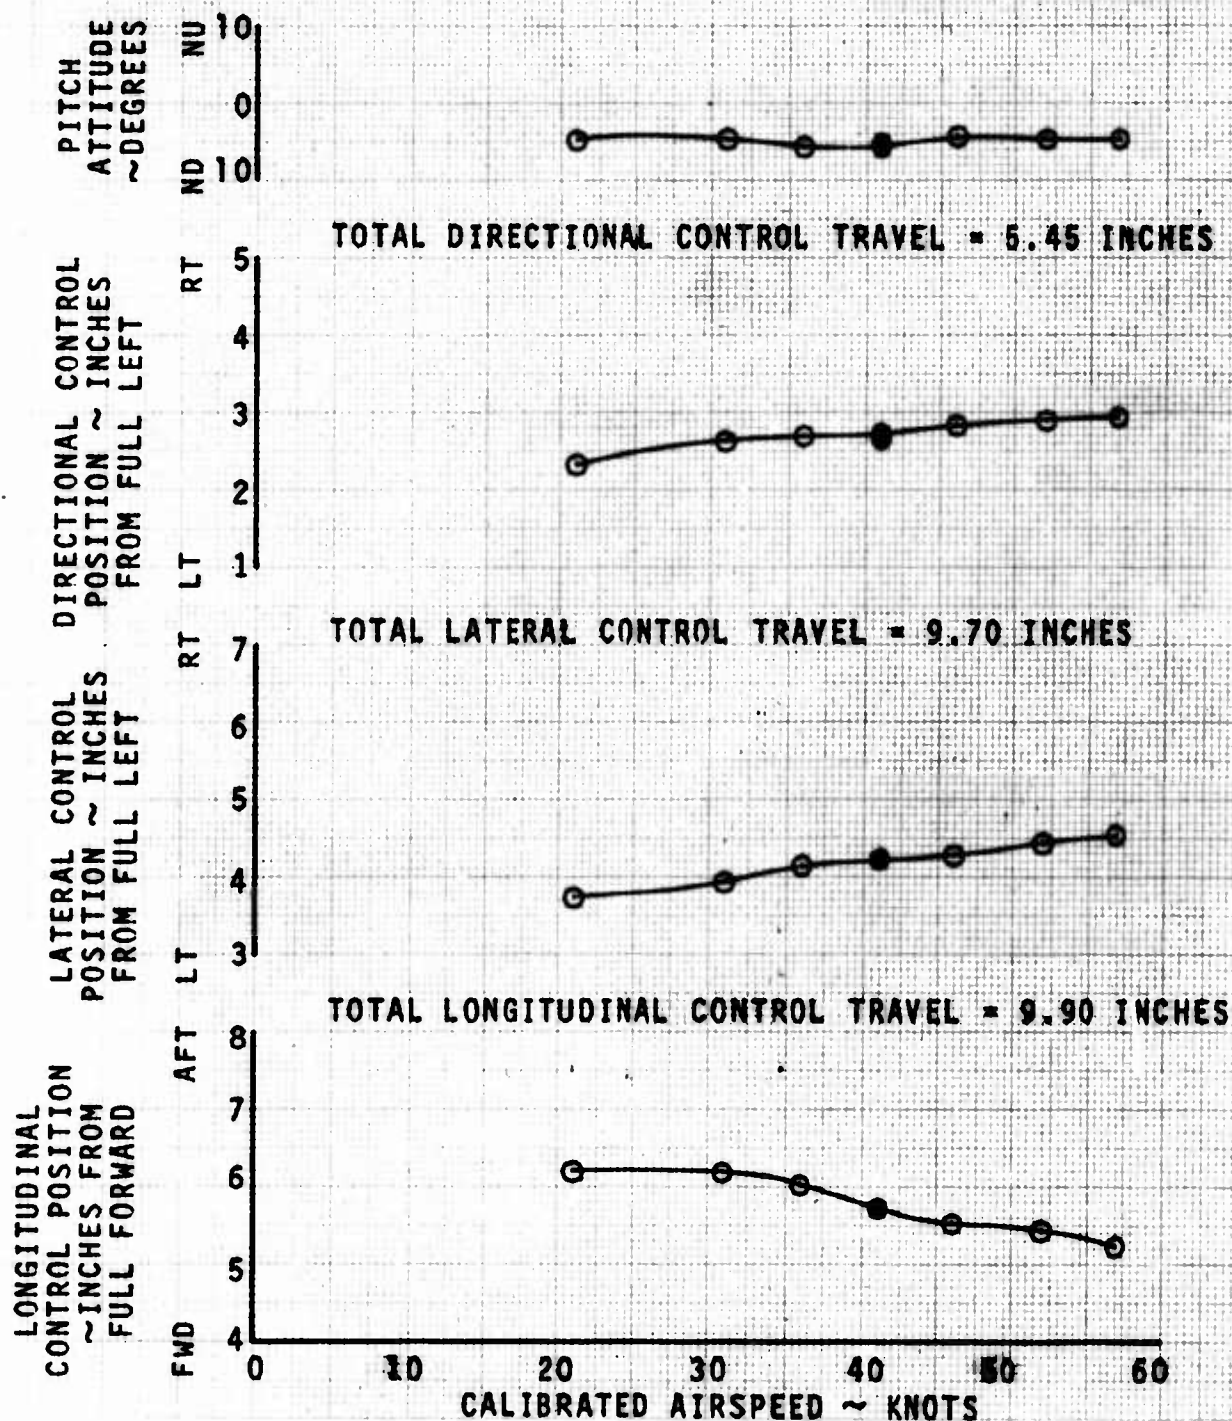
**FIGURE 8**  
**COLLECTIVE-FIXED STATIC LONGITUDINAL STABILITY**  
**YAH-1R USA S/N 70-15936**

AVG GROSS WEIGHT ~LB	AVG CG LOCATION LONG FS	AVG LAT BL	AVG DENS ALT ~FT	AVG OAT ~°C	AVG ROTOR SPEED ~RPM	AVG C <sub>T</sub> ~10 <sup>4</sup>	CONFIG	FLT COND
10,080	199.5(AFT)	-0.1(LT)	5100	2.5	324	58.27	HQ	LEVEL FLT

- NOTES: 1) SHADED SYMBOLS DENOTE TRIM  
 2) COLLECTIVE CONTROL POSITION = 2.5 INCHES FROM FULL DOWN  
 3) ANGLE OF SIDESLIP = ZERO DEGREES

11. Collective-fixed static longitudinal stability was evaluated at the conditions shown in table 1. The helicopter was trimmed in steady-heading zero sideslip flight at the desired trim airspeed. Then, with the collective stick held fixed, the helicopter

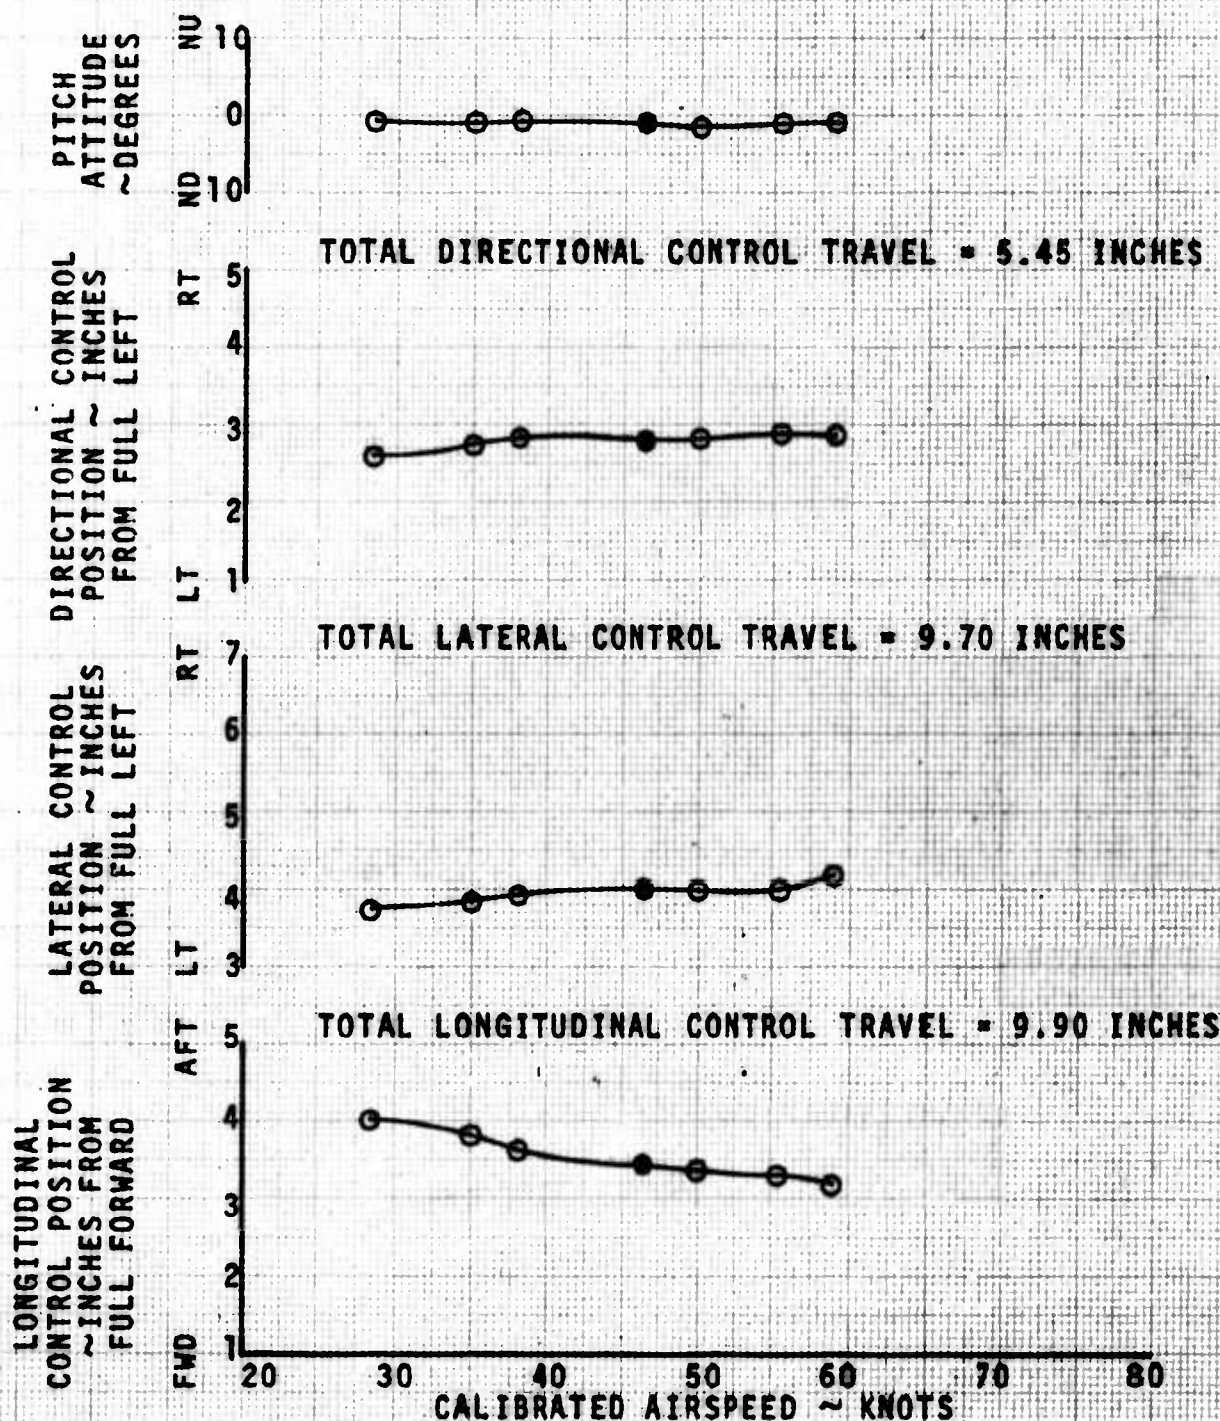
# FIGURE 9 COLLECTIVE-FIXED STATIC LONGITUDINAL STABILITY

AVG GROSS WEIGHT ~LB	AVG CG LOCATION		AVG DENS ALT ~FT	AVG OAT ~°C	AVG ROTOR SPEED ~RPM	AVG C <sub>T</sub> ~10 <sup>4</sup>	CONFIG	FLT COND
	LONG FS	LAT BL						
9810	199.4(AFT)	-0.1(LT)	5100	3	324	56.71	NOB	DIVE

- NOTES: 1) SHADED SYMBOLS DENOTE TRIM  
2) COLLECTIVE CONTROL POSITION = 3.2 INCHES FROM FULL DOWN  
3) ANGLE OF SIDESLIP = ZERO DEGREES

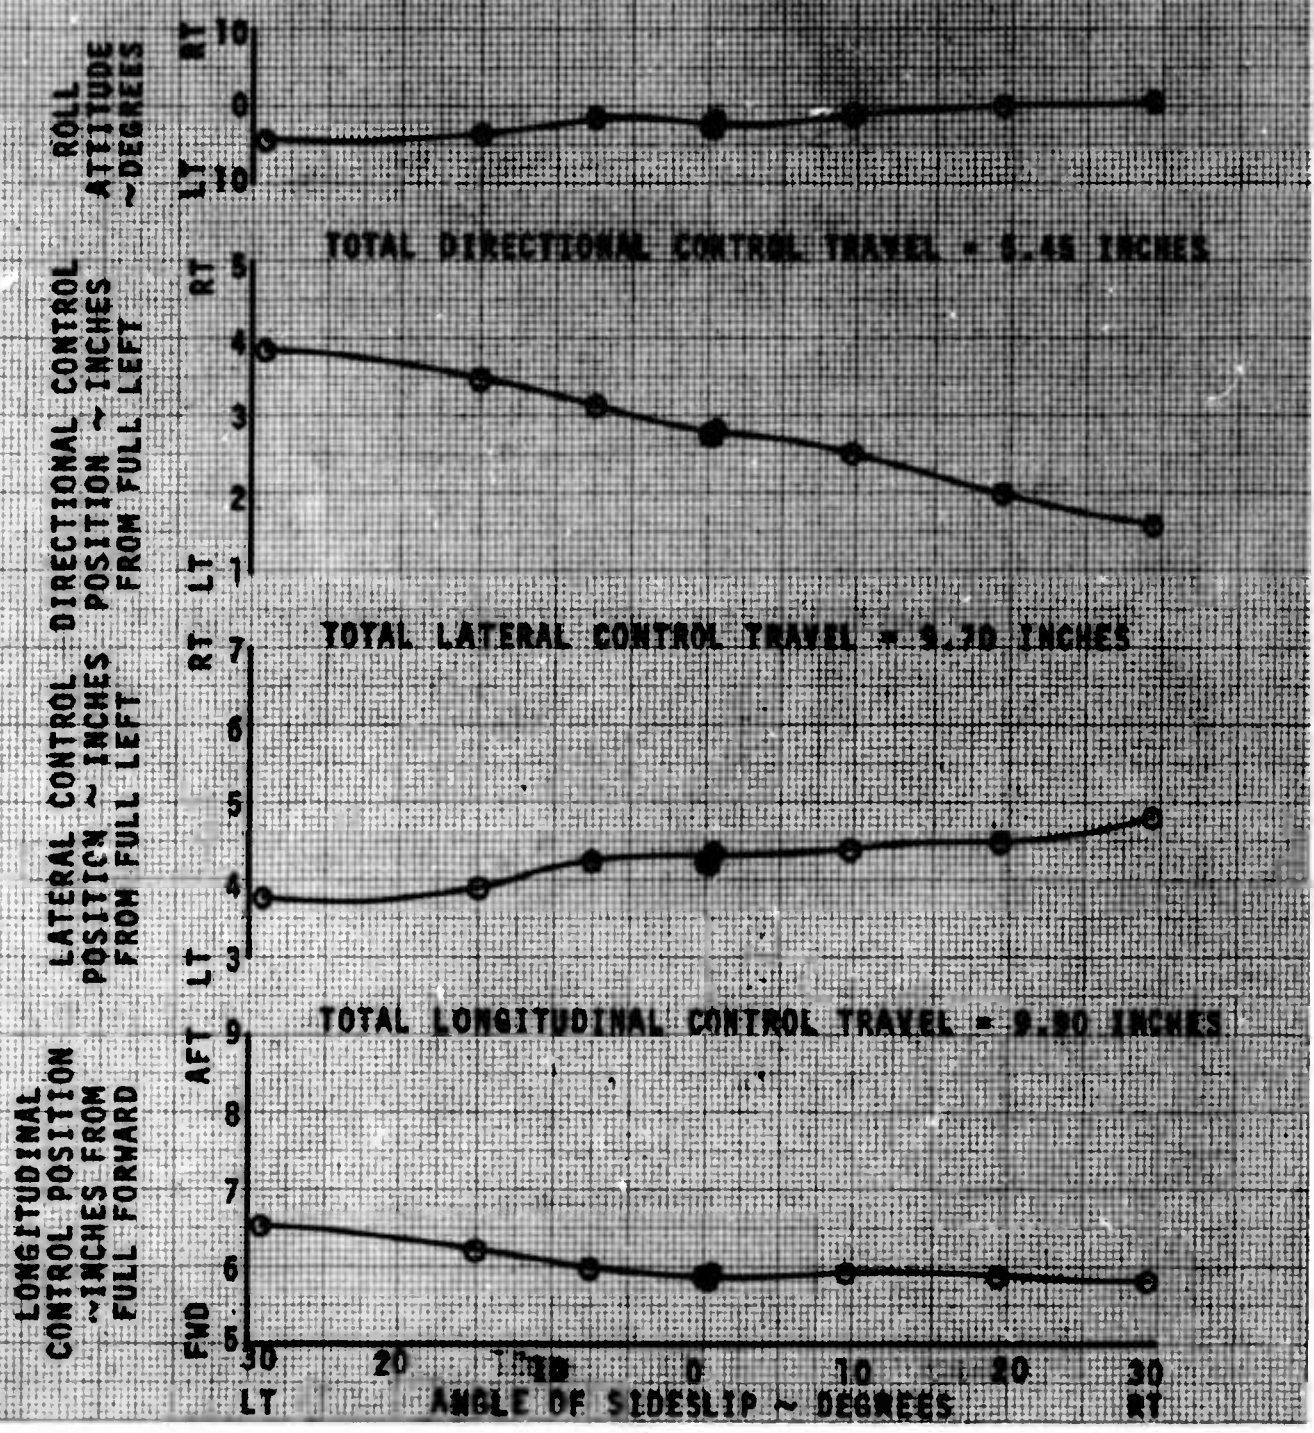
**FIGURE 11**  
**STATIC LATERAL DIRECTIONAL STABILITY**  
**YAH-1R USA S/N 70-15936**

NOTES: 1) SHADED SYMBOLS DENOTE TRIM  
 2) COLLECTIVE CONTROL POSITION = 2.6 INCHES FROM FULL DOWN

15. Static lateral-directional stability characteristics were determined at the conditions shown in table 1. The aircraft was initially trimmed in zero sideslip level flight or in a dive at the desired airspeed. With the collective control fixed and airspeed held constant, the aircraft was stabilized at incremental sideslip angles from zero to the limit of the sideslip envelope. Test results are presented in figures 10 through 12, appendix E.

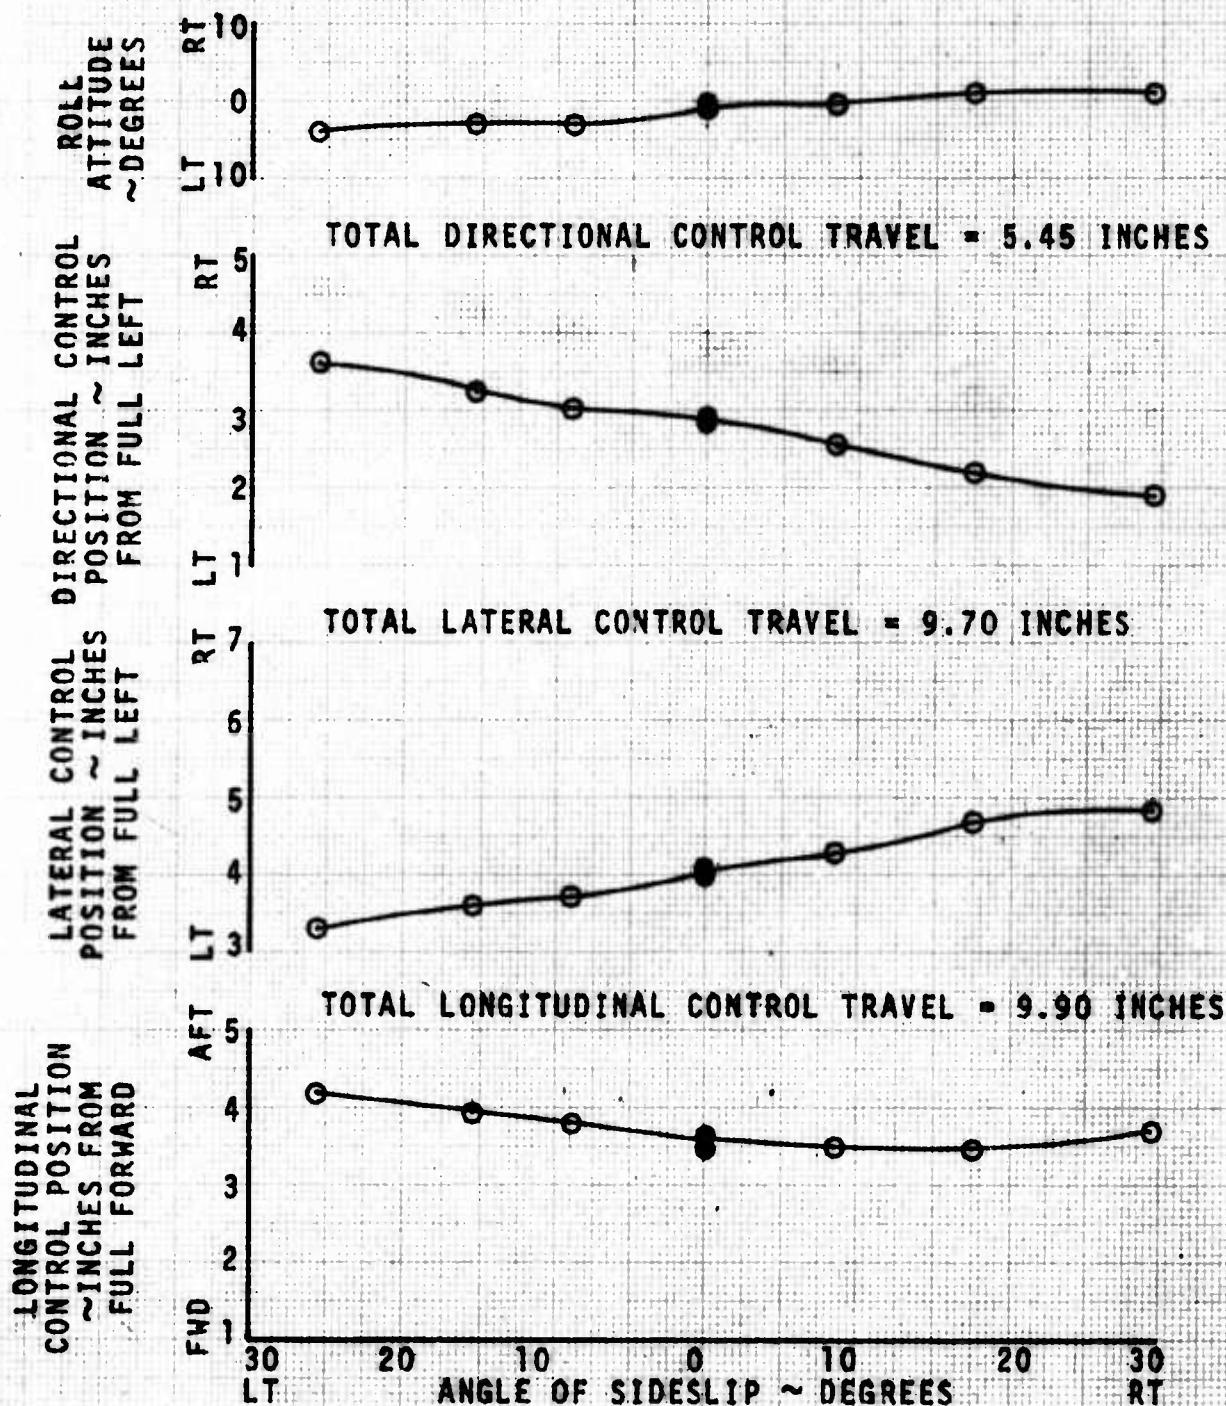
# FIGURE 12 STATIC LATERAL DIRECTIONAL STABILITY YAN-12 USA S/N 70-15936

NOTES: 1) SHADED SYMBOLS DENOTE TRIM  
 2) COLLECTIVE CONTROL POSITION = 3.2 INCHES FROM FULL DOWN

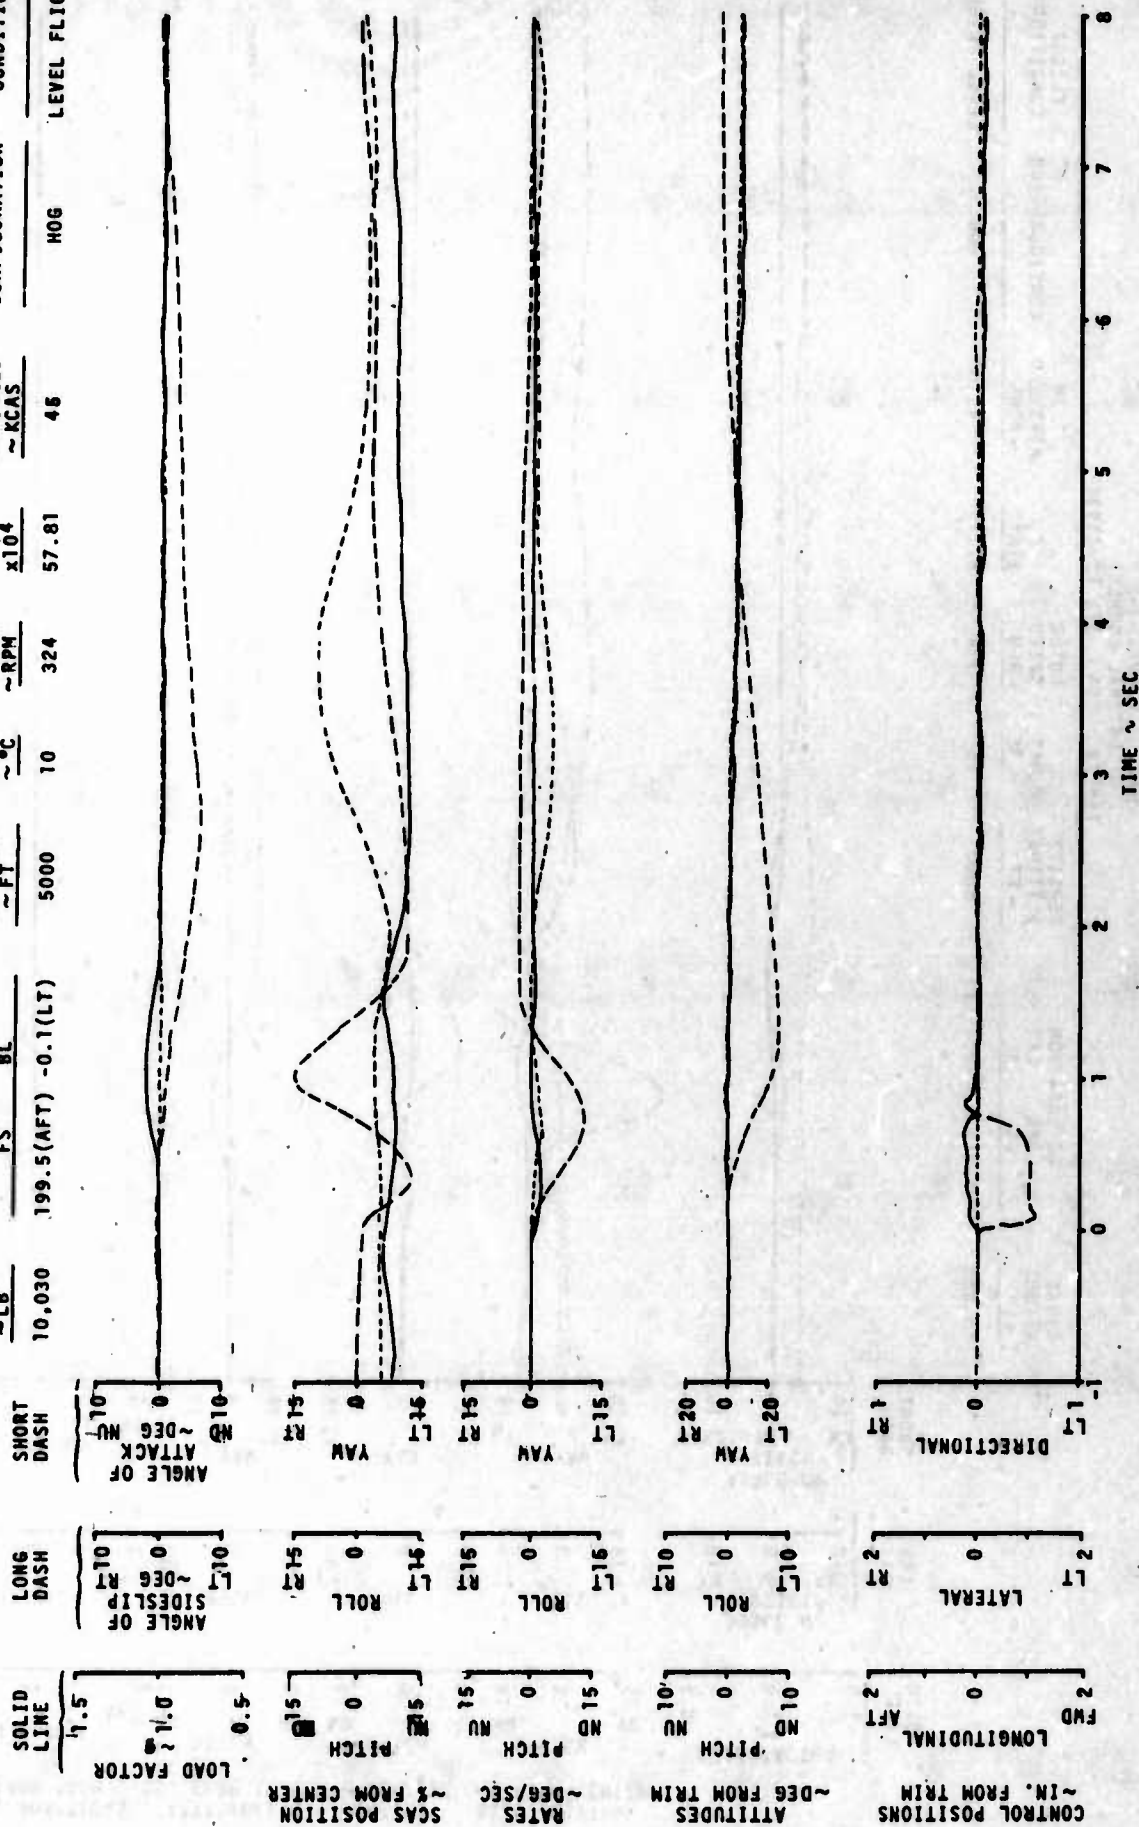
FIGURE 14  
LATERAL DOUBLET  
YAH-1R USA S/N 70-15936

GROSS WEIGHT ~LB	CG LOCATION LONG FS LAT BL	DENSITY ALTITUDE ~FT	OAT ~°C	ROTOR SPEED ~RPM	C <sub>T</sub> x10 <sup>4</sup>	TRIM AIRSPEED ~KCAS	CONFIGURATION	FLIGHT CONDITION
10,020	199.5(AFT) -0.1(LT)	5000	10	324	57.75	45	HOG	LEVEL FLIGHT

20. The longitudinal and lateral-directional dynamic stability of the YAH-1R helicopter was evaluated at the conditions shown in table 1 with SCAS ON and SCAS OFF. Short-term dynamic responses, simulating gust response, were evaluated by rapidly pulsing the cyclic control and pedals 1 inch for a duration of approximately 1/2 second, then returning the control to the trim position. Short-term response was further evaluated by control doublets. Time histories of representative dynamic responses are presented in figures 13 through 24, appendix E.

22. The principal response mode of the YAH-1R helicopter to external gust input was a coupled roll-yaw oscillation (Dutch roll). Time histories of this response mode are shown in figures 13 through 24, appendix E. Although this oscillation was noticeable in flight with SCAS ON, it was positively damped without pilot input and easily damped by the pilot to achieve satisfactory flight conditions to launch rockets (HQRS 3). With SCAS OFF, the lateral-directional oscillation was lightly damped and easily excited by external gusts; however, the aircraft handling qualities are acceptable for flight in this degraded mode. Maintaining an airspeed below 100 KIAS for SCAS OFF flight, as currently recommended for the AH-1G, reduces pilot effort. Qualitatively, the YAH-1R short-period dynamics are similar to the standard AH-1G at a power setting of 1100 shp or below. At power settings above 1100 shp, the SCAS-OFF divergence is more pronounced.
